**Tingewick Village Hall**

**Visual Inspection with Recommendations for Repairs  
with Proposals for a Full ongoing Maintenance Regime.**

December 1<sup>st</sup> 2010.

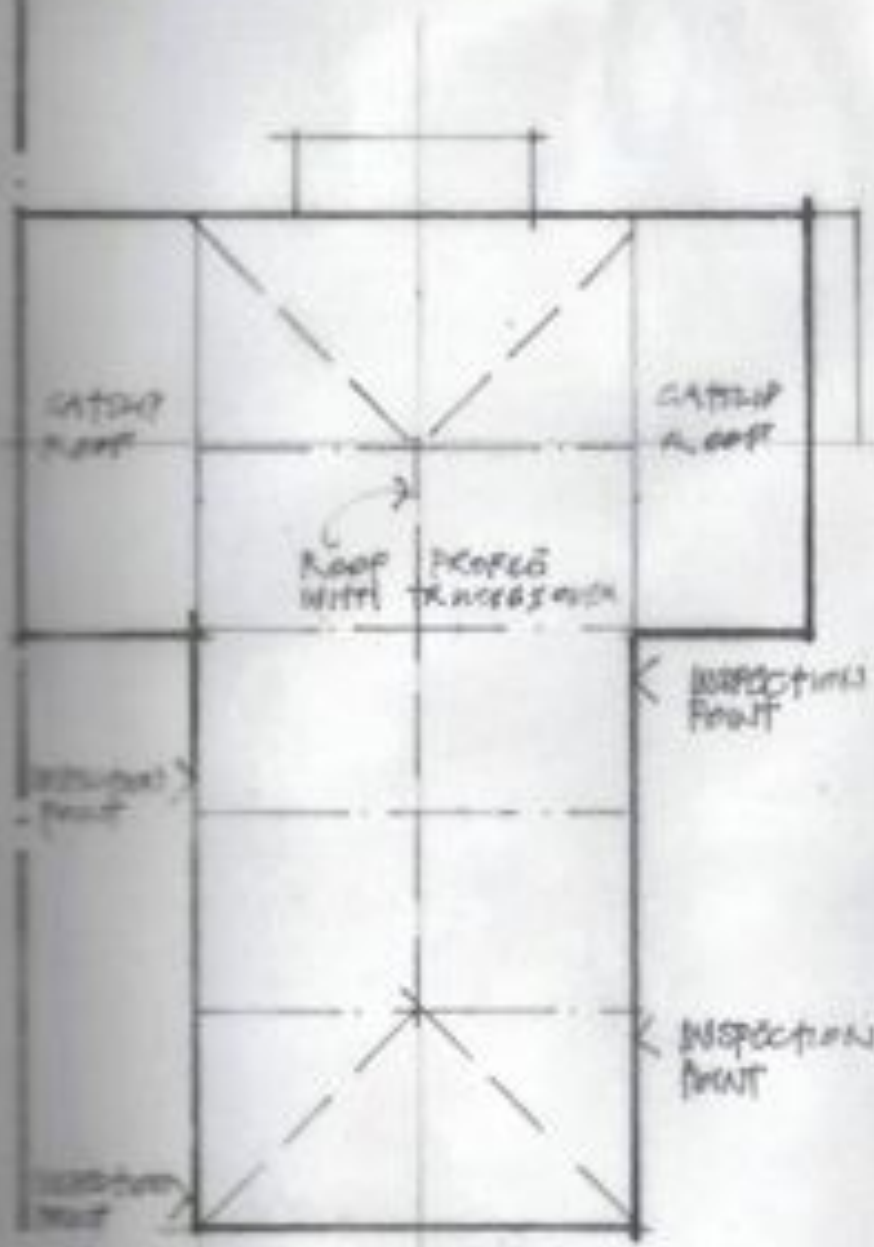
PROPOSED IN RETAINING WALL

4 sections of boarding were removed for detailed inspection of the structure, these are noted on the enclosed sketch drawing.

The 2 separate positions of the removal along the west side clearly highlighted the results of the high ground levels adjacent. The panel immediately adjacent to the door

from the meeting room had rotted through and essentially fell apart during the extraction. The other although not quite as badly rotten will certainly end up in the same condition without some remedial action. Points along the East face revealed the structural post support for the roof trusses which although larger than the main framing is not in excess capacity. The small opening adjacent to the Female toilet revealed the inadequacy of the thermal insulation.

4.0. To reduce the adjacent ground level along the external wall.	Immediately
5.0. Construct dwarf retaining wall 1m from the rear hall wall to create Path at correct level. In conjunction with item 5.0. above.	Immediately

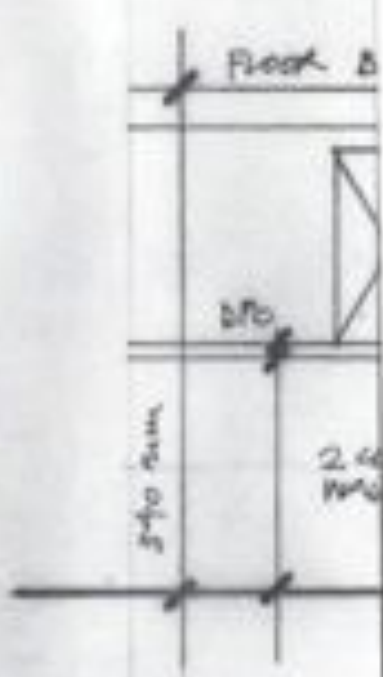
OPTION A  
FLOOR P

There is currently a problem of excessive bounce and knocking noises from certain sections of the floor when walking heavily across. The bounce to the floor is very distinct along the central line of sleeper walls within the hall and within the areas between the 2<sup>nd</sup> and 3<sup>rd</sup> trusses working from the kitchen end of the hall. When checked against a string line the depression within these areas was up to 10mm in depth.

In my opinion this problem could be caused by either;

- a. The new floor boards parting their connection from the joists

If we now consider what the rectification options for both these items the easiest and possibly the cheapest initial solution to approach I would suggest would be carried out on option a. It would be relatively easy to screw and pellet along the line of the sleeper wall and reconnect the floor boards onto the joists below with minimum visual disturbance to the floor when sanded off. This first option which hopefully would reinstate a connection strong enough to bind the board and joist together would create an overall interconnected diaphragm bearing fully on the sleeper walls below.

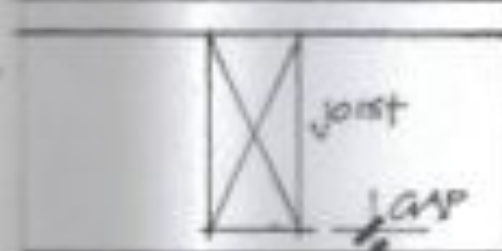
OPTION B

- b. The combined floor boards and joists parting from the connection onto the dpc running along the top of the sleeper wall, which may include any possible packers under the joists having dropped out.

Option b. If the option a above fails this becomes the next possibility to consider. It would involve a much larger area of the floor having to be lifted in order to open up the void and repack between the underside of the joists and the top of the sleeper walls. The area of disturbance would be within the middle section of the hall floor and connecting both areas of the bouncing problem. Visually the effects of the side and end saw cuts, which are necessary to cut through the tongue of the board, could be reduced by mixing the sawdust produced from the sawing with a bonding agent and scraping into the joints and sanding down.
